Flood Control Project Maintenance**2013 Structure Summary Report****Overall Unit and Item Ratings****Butte County Public Works Department****Big Chico Creek Diversion Structure**

Flood Control Project Maintenance**Unit Cover Sheet****2013 Structure Inspection Results****Butte County Public Works Department**

Structure
Big Chico Creek Diversion Structure

**Flood Control Project Maintenance
Levee Inspections**

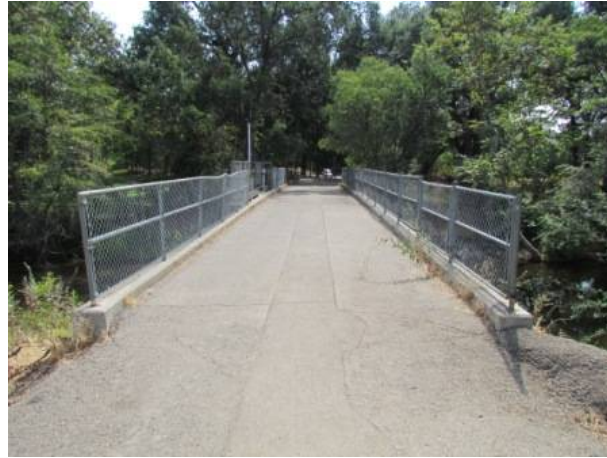
mhoffman_t_20130807_035.JPG

This is a view of the structure from the bike path.

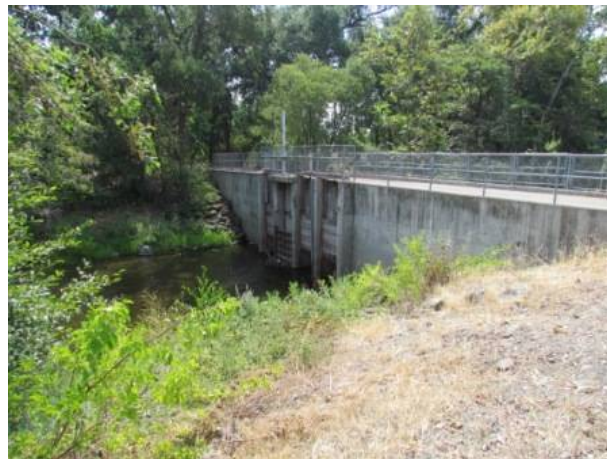
mhoffman_t_20130807_036.JPG

This is a view of the structure from upstream.

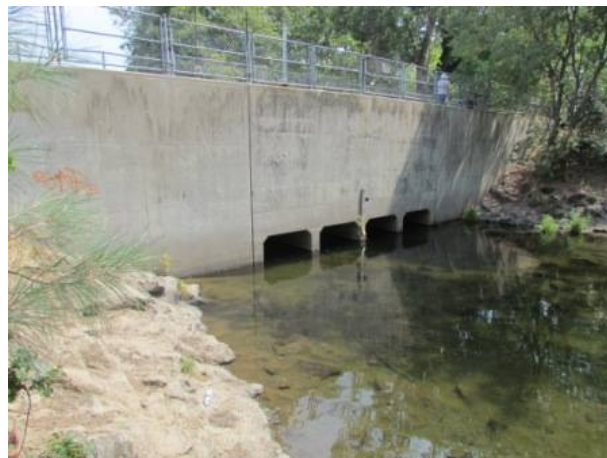
mhoffman_t_20130807_037.JPG

This is a view of the structure from downstream.

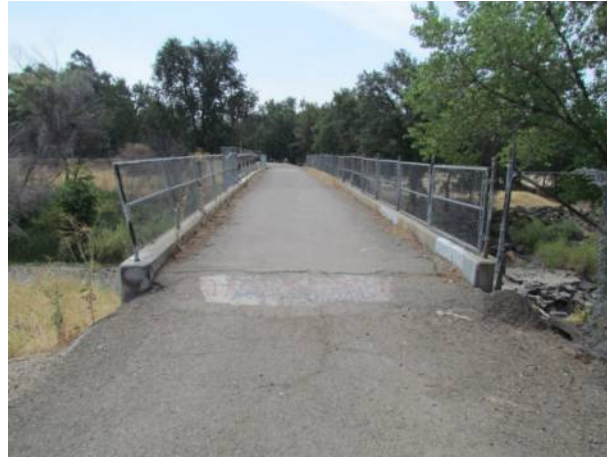
mhoffman_t_20130807_039.JPG

This is a view of the structure from the bike trail.

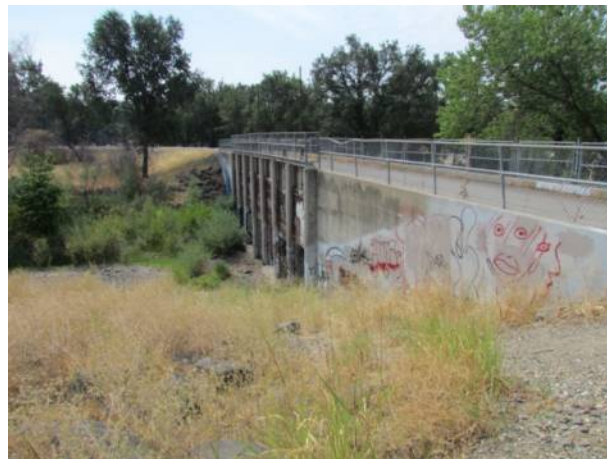
mhoffman_t_20130807_040.JPG

This is a view of the structure from upstream.

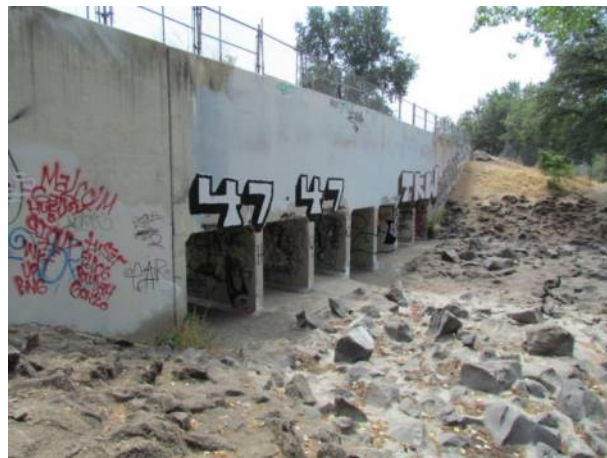
mhoffman_t_20130807_041.JPG

This is a view of the structure from downstream.

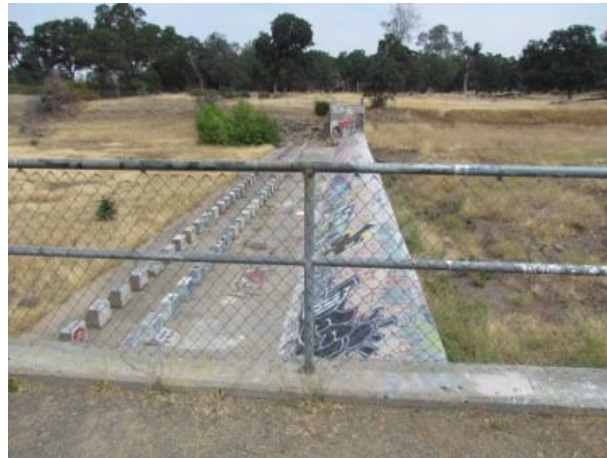
mhoffman_t_20130807_038.JPG

This is a view of the weir.
